Periglacial Geohazards at the Colne Valley South Embankment and Chiltern Tunnel Ventilation Shaft Design

West Midlands Regional Group of The Geological Society

April 2024

Guillermo Mondejar (Jacobs)

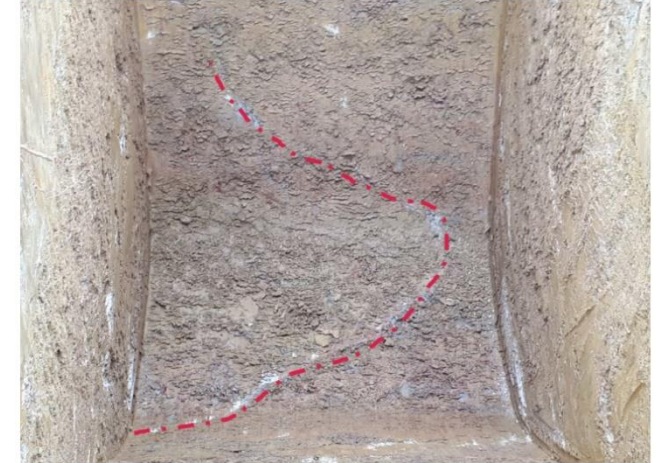
Polished slip surface at 2.0m depth, showing the morphology of the slip surfaces

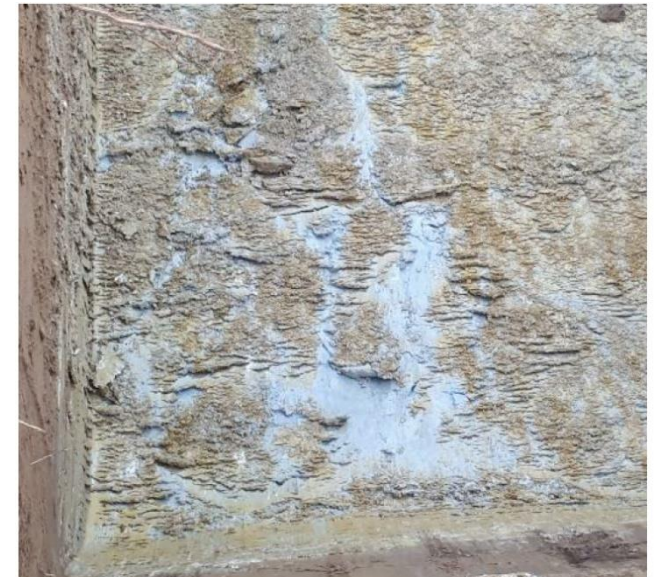
Relict Landslip feature identified at 4.5 to 5.0m depth

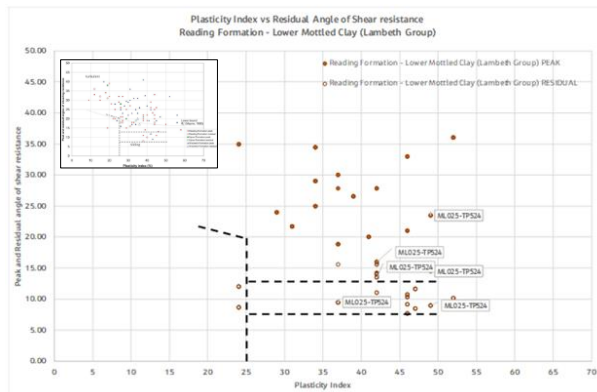
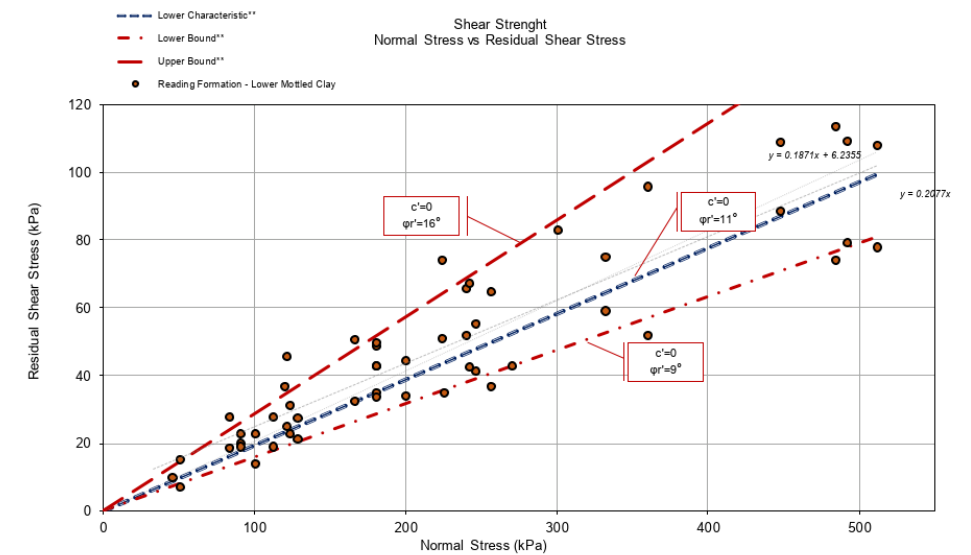
It was concluded that the data validated design values to be set based on lower characteristic values compared to preliminary design.

GL to 8m depth design on residual shear strength properties:

- $C'_r = 0\text{kPa}$
- $\Phi'_r = 11\text{ degrees}$

>8m depth design on peak shear strength properties:

- $C'_p = 0\text{kPa}$
- $\Phi'_p = 20\text{ degrees}$

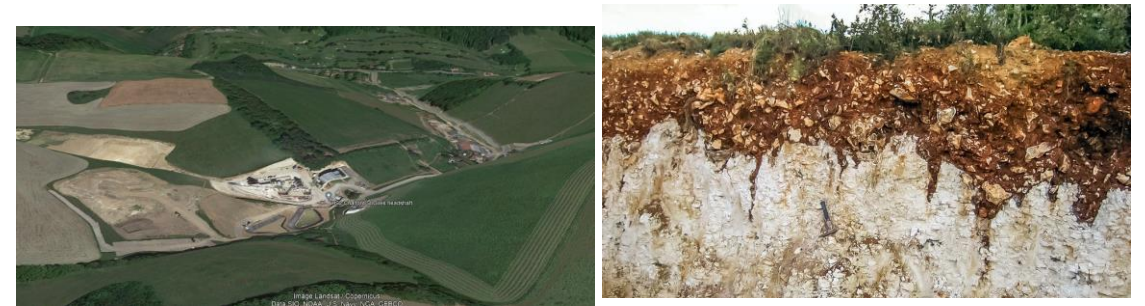
Desk Study Long Section

- Shafts located to limit the amount of excavation
- Typically located in chalk dry valleys with variable thickness of Clay-with-Flints and high presence of dissolution features within the Chalk
- Example from Chalfont St Giles – Junction of 3 dry valleys

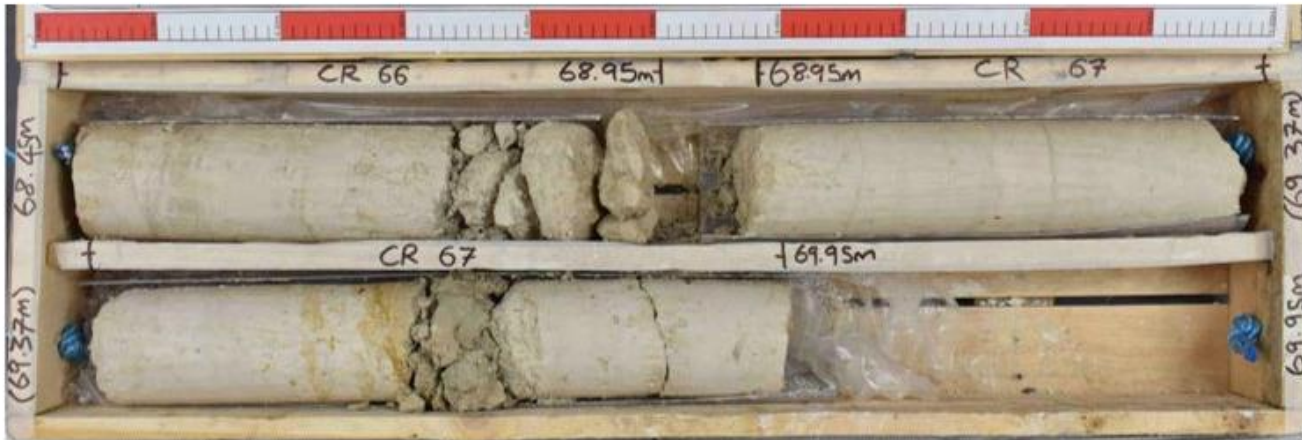
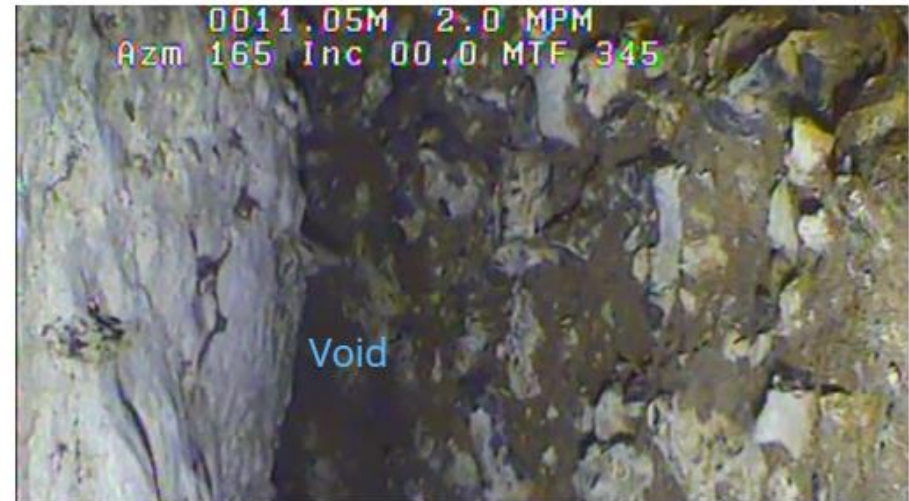
Ground Investigation in chalk is complicated by chalk weathering and tendency to breakup during drilling. Shaft design required clear identification of chalk condition:

- Completely weathered chalk soil
- Weathered chalk with some structure but open / infilled joints
- Competent chalk with closed fissures
- Geological fault zones & dissolution features

Chalfont St Giles – Televueer looking horizontally

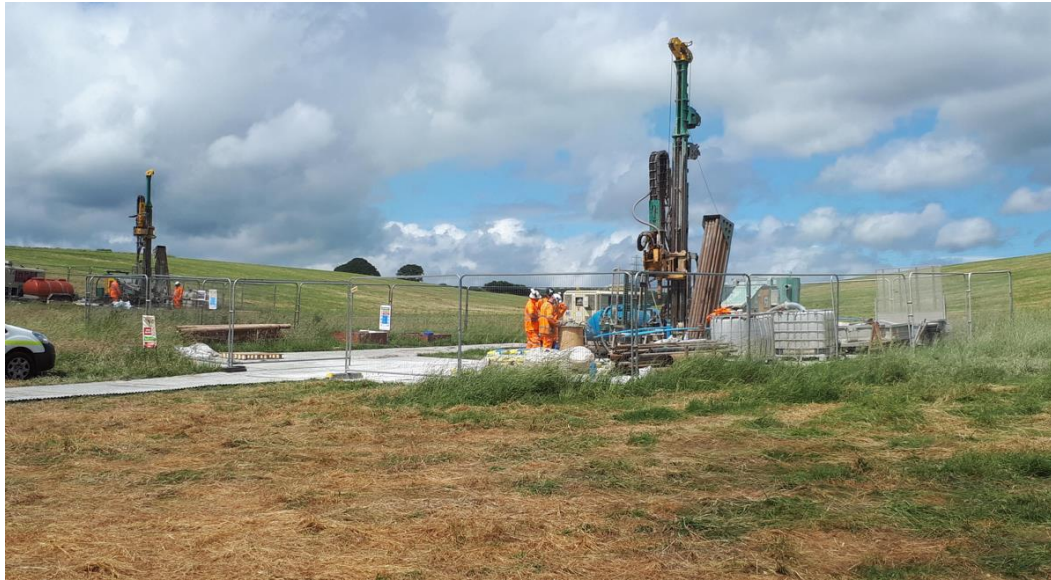
Chalfont St Giles

Ground Investigation

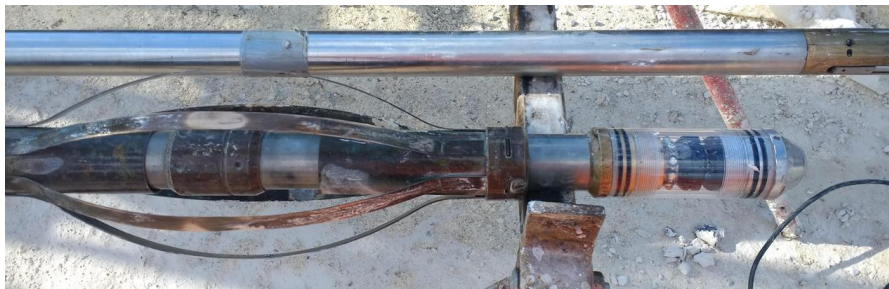
HPD

Cross-hole seismic geophysics (V_s , V_p)

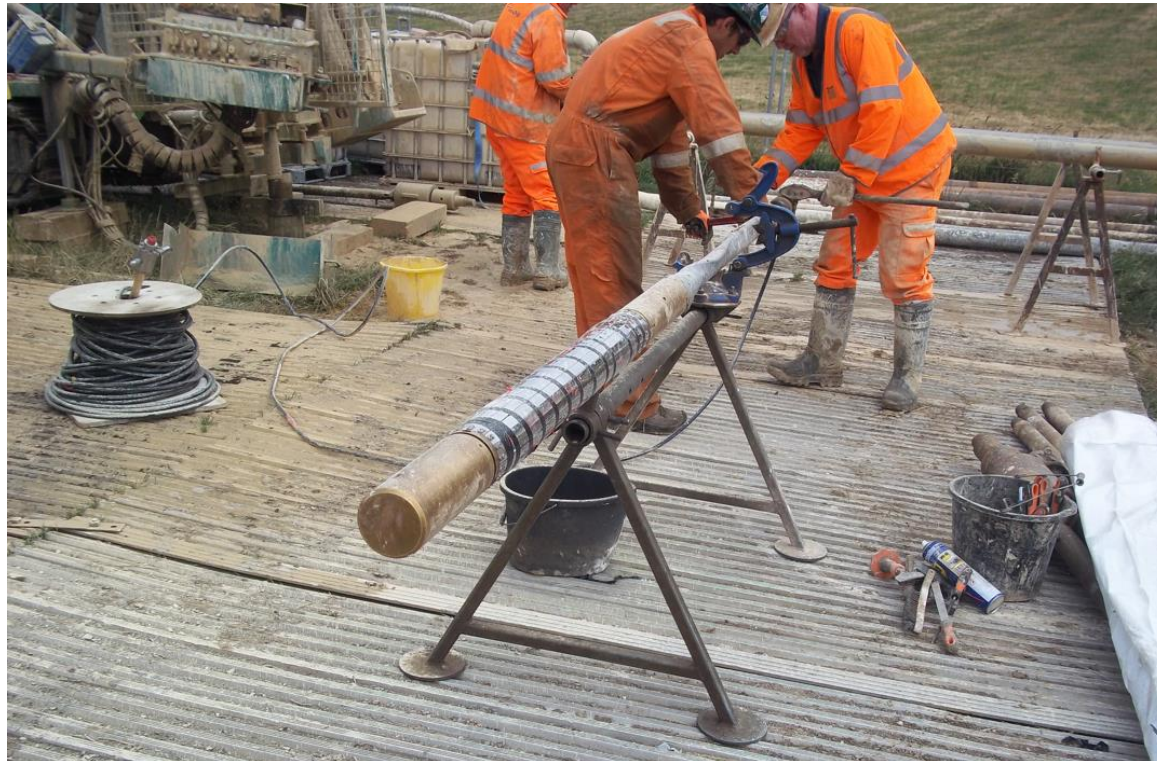
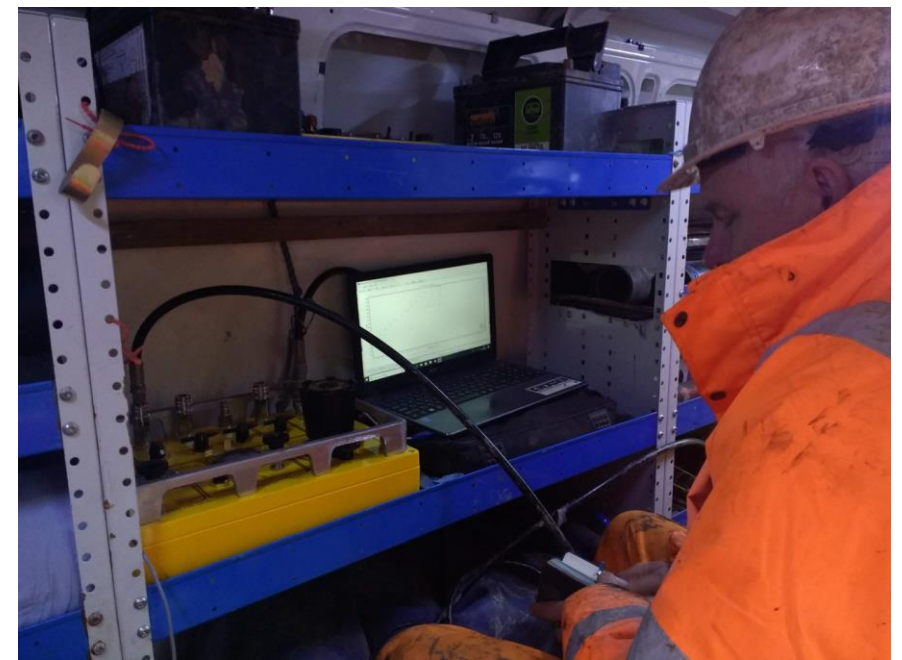
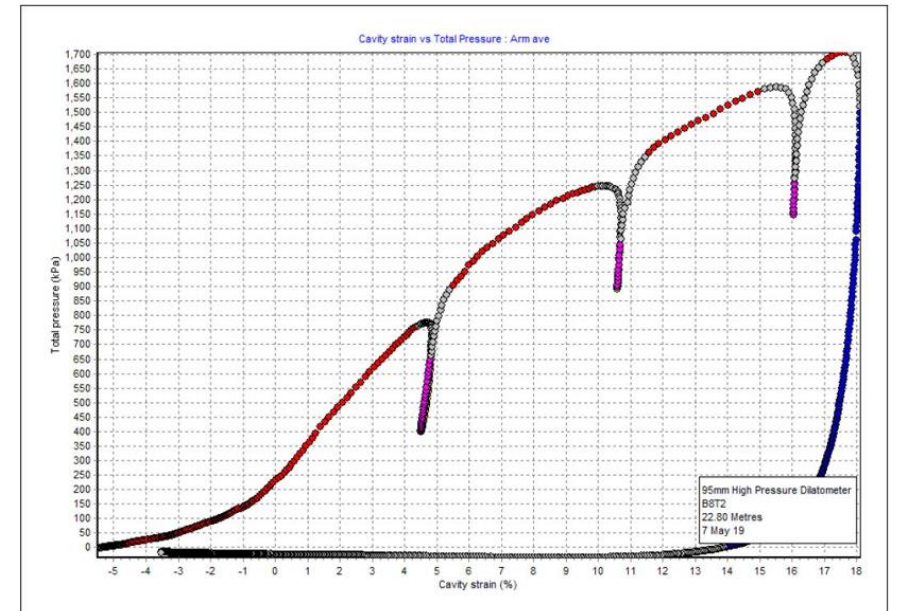
Soil properties for design

- Pumping well tests: mass permeability (before & after D-wall)
- Pressuremeter testing: Es50 & horizontal earth pressure for K_0
- Cross-hole geophysics: small strain stiffness

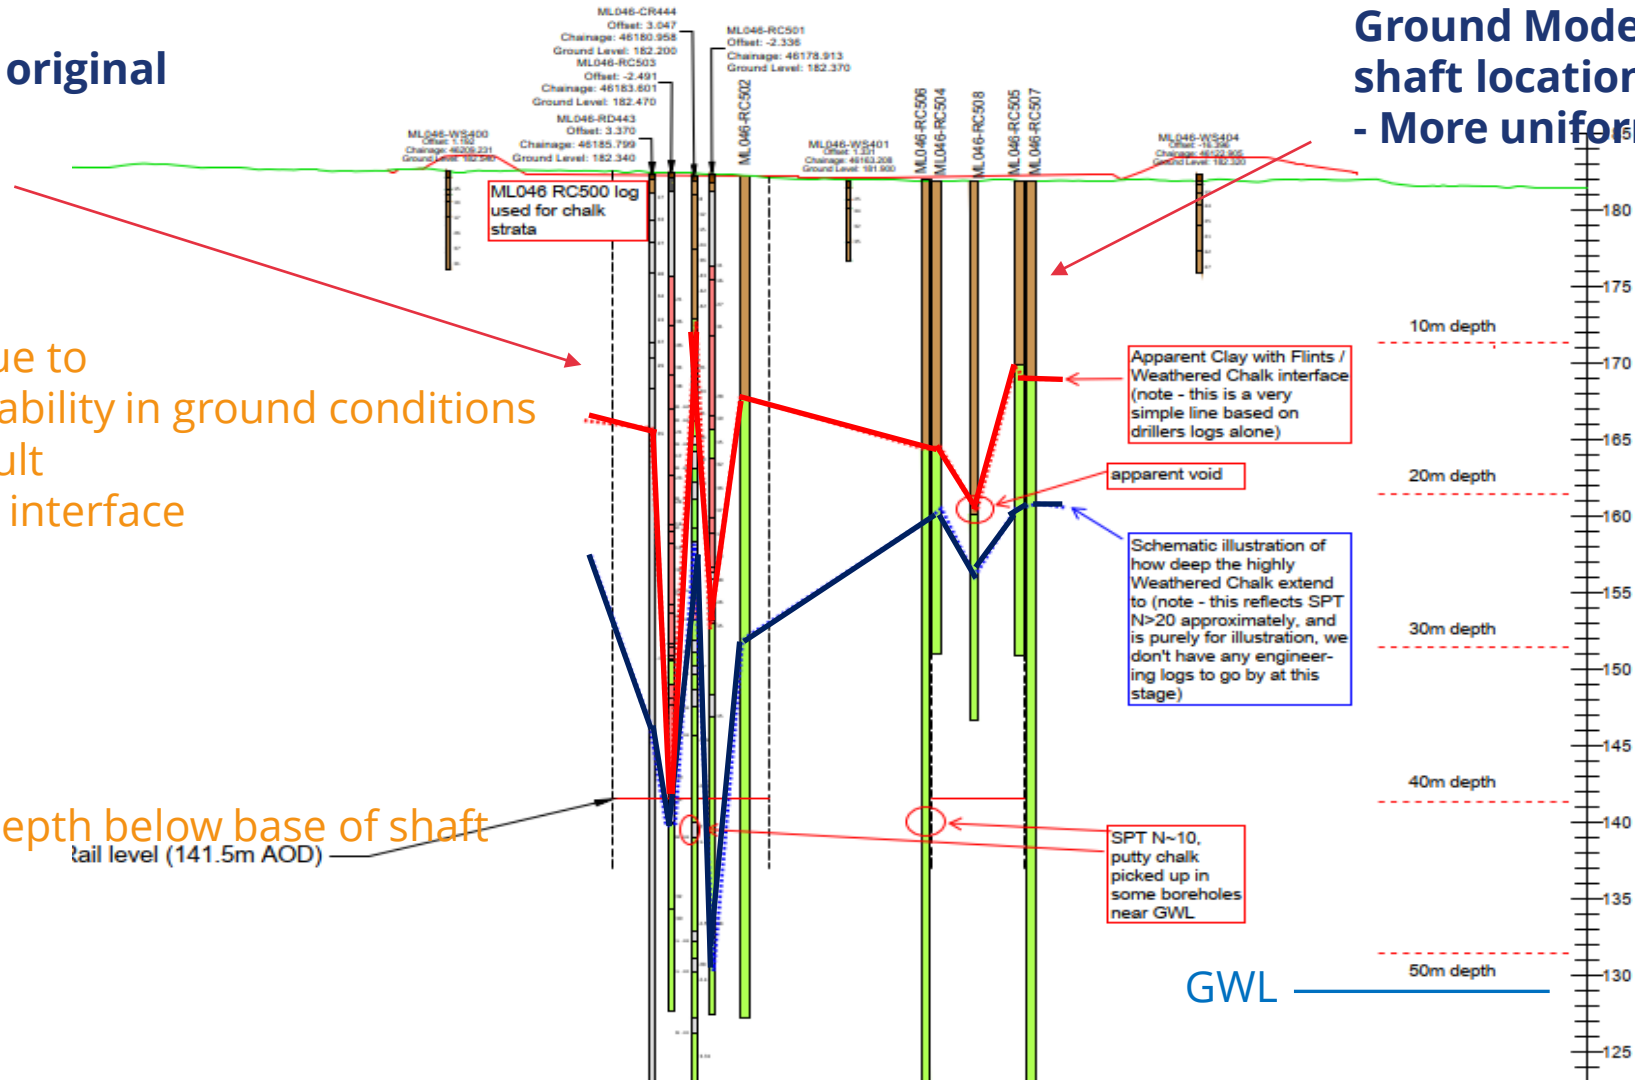
Ground Model at original shaft location
- More variation

- Shaft relocated due to
- significant variability in ground conditions
 - Presence of fault
 - Depth of chalk interface

Groundwater at depth below base of shaft
tail level (141.5m AOD)

Ground Model at new shaft location
- More uniform

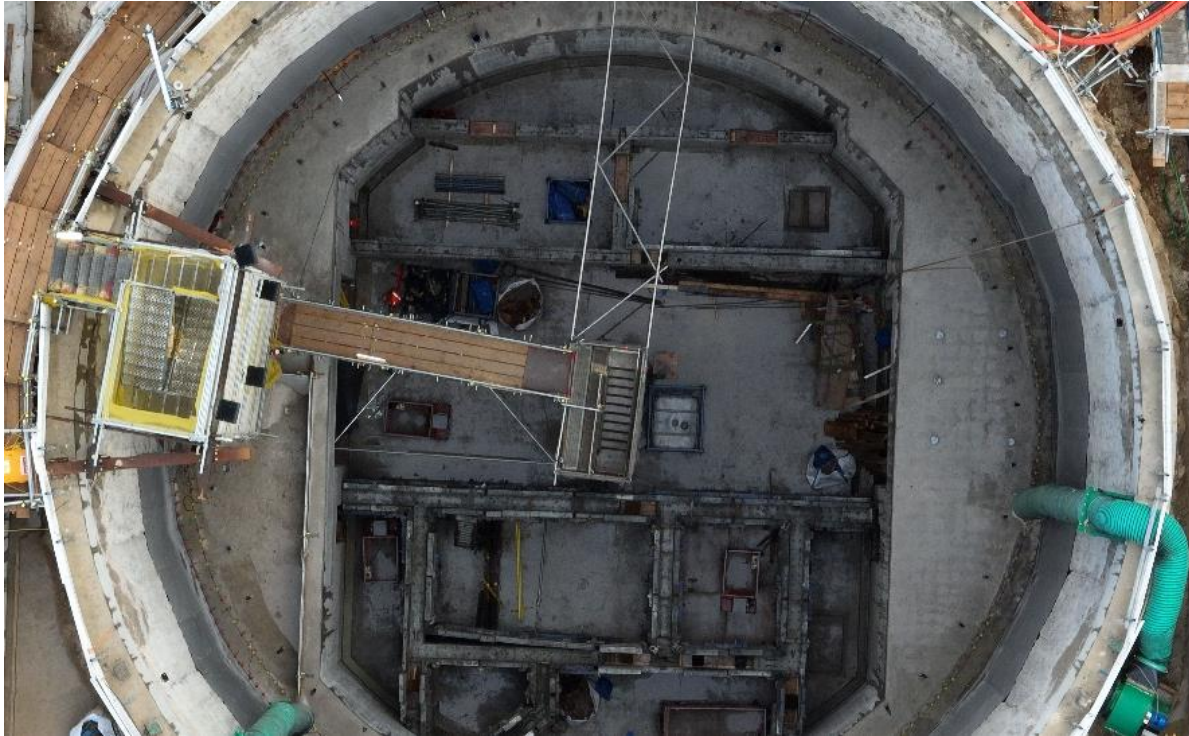
Chalfont St Giles September 2022

Construction

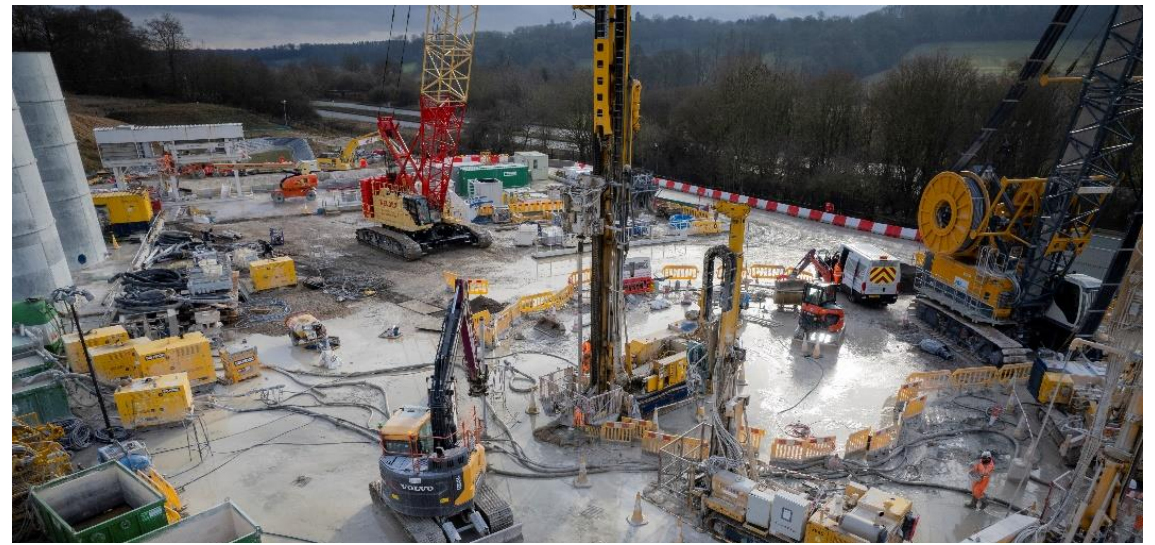
Chalfont St Peter Ground Treatment

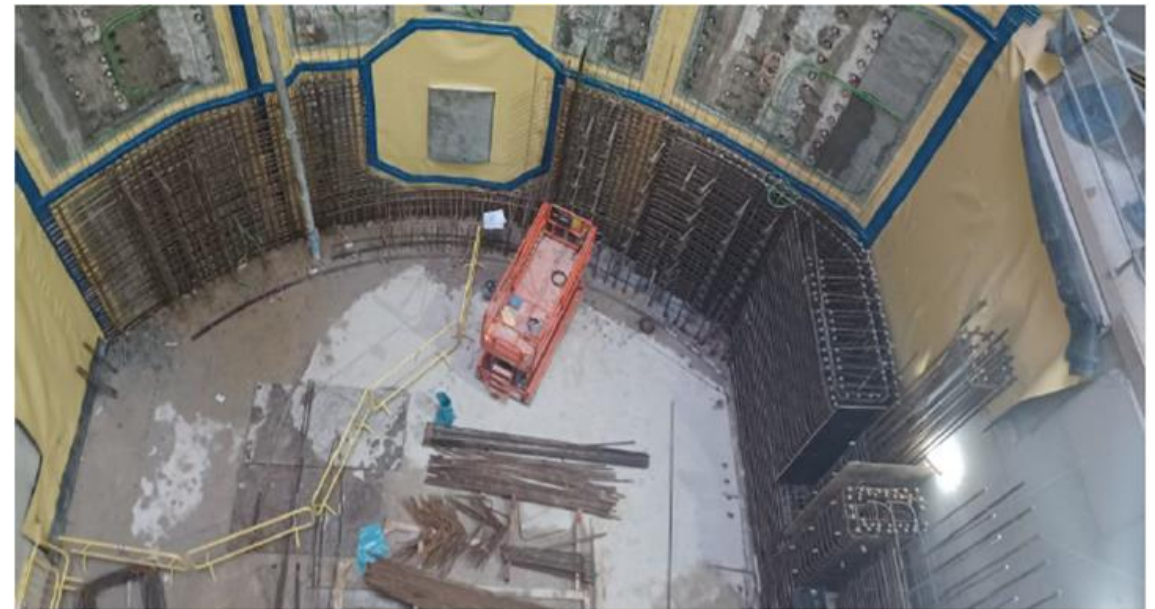
Chalfont St Peter Collar Installation

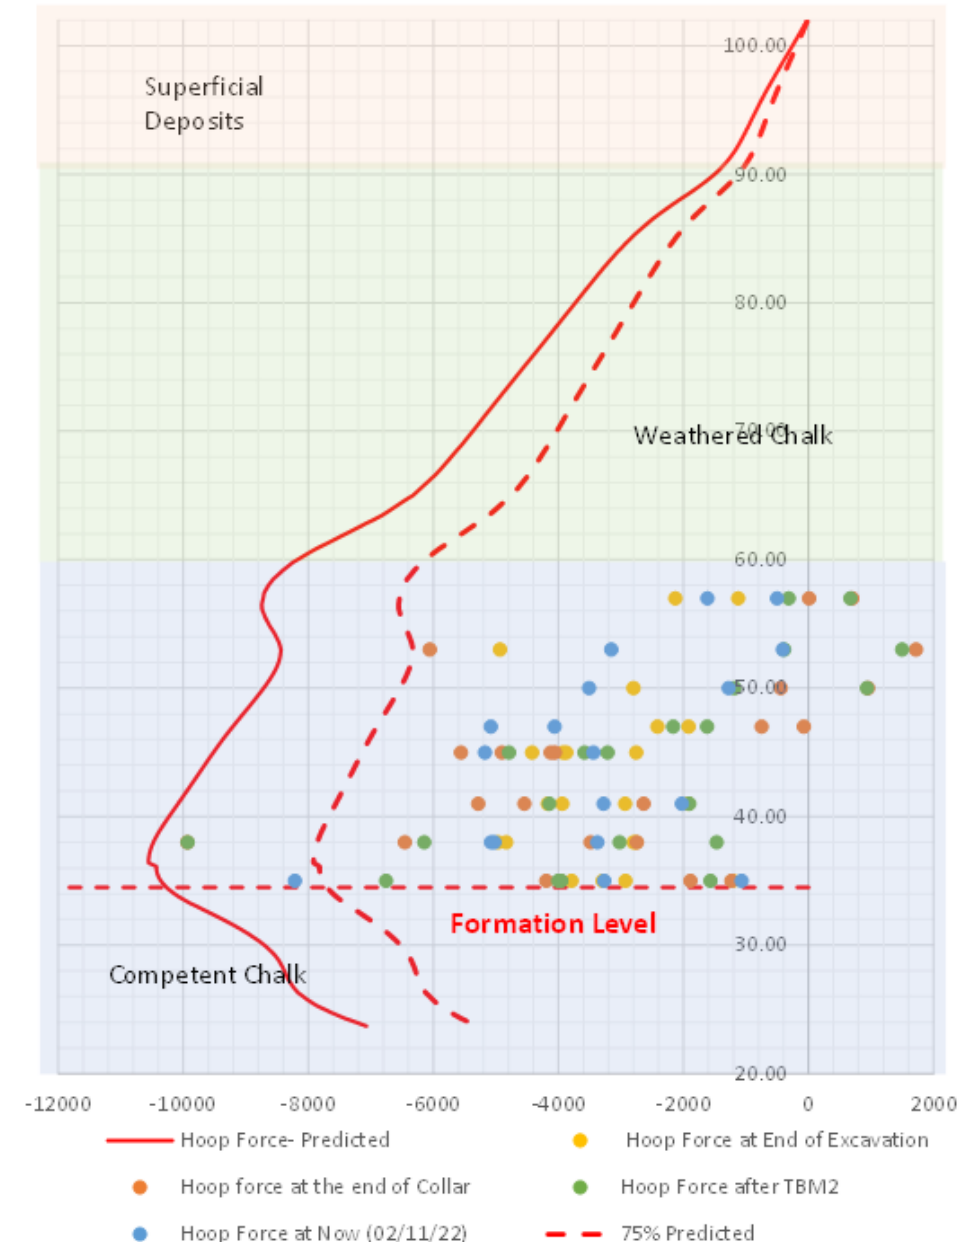
Actual v Predicted

Hoop forces are key to shaft stability

Geotechnical design set instrumentation trigger values

- Stresses
- Strain

Monitoring demonstrated:

- compliance with trigger values
- also validated the design parameters used

$$K_{0-3} = \frac{\sigma'_h}{\sigma'_v} = 1.05 \text{ affecting the shafts during excavation}$$
