## Introduction

Waun Fawr is a groundwater dependent ecosystem made up of dry wet heath and marshy grassland located near St Davids, Pembrokeshire. It is a designated SAC and SSSI.

Actions under Outcome 21

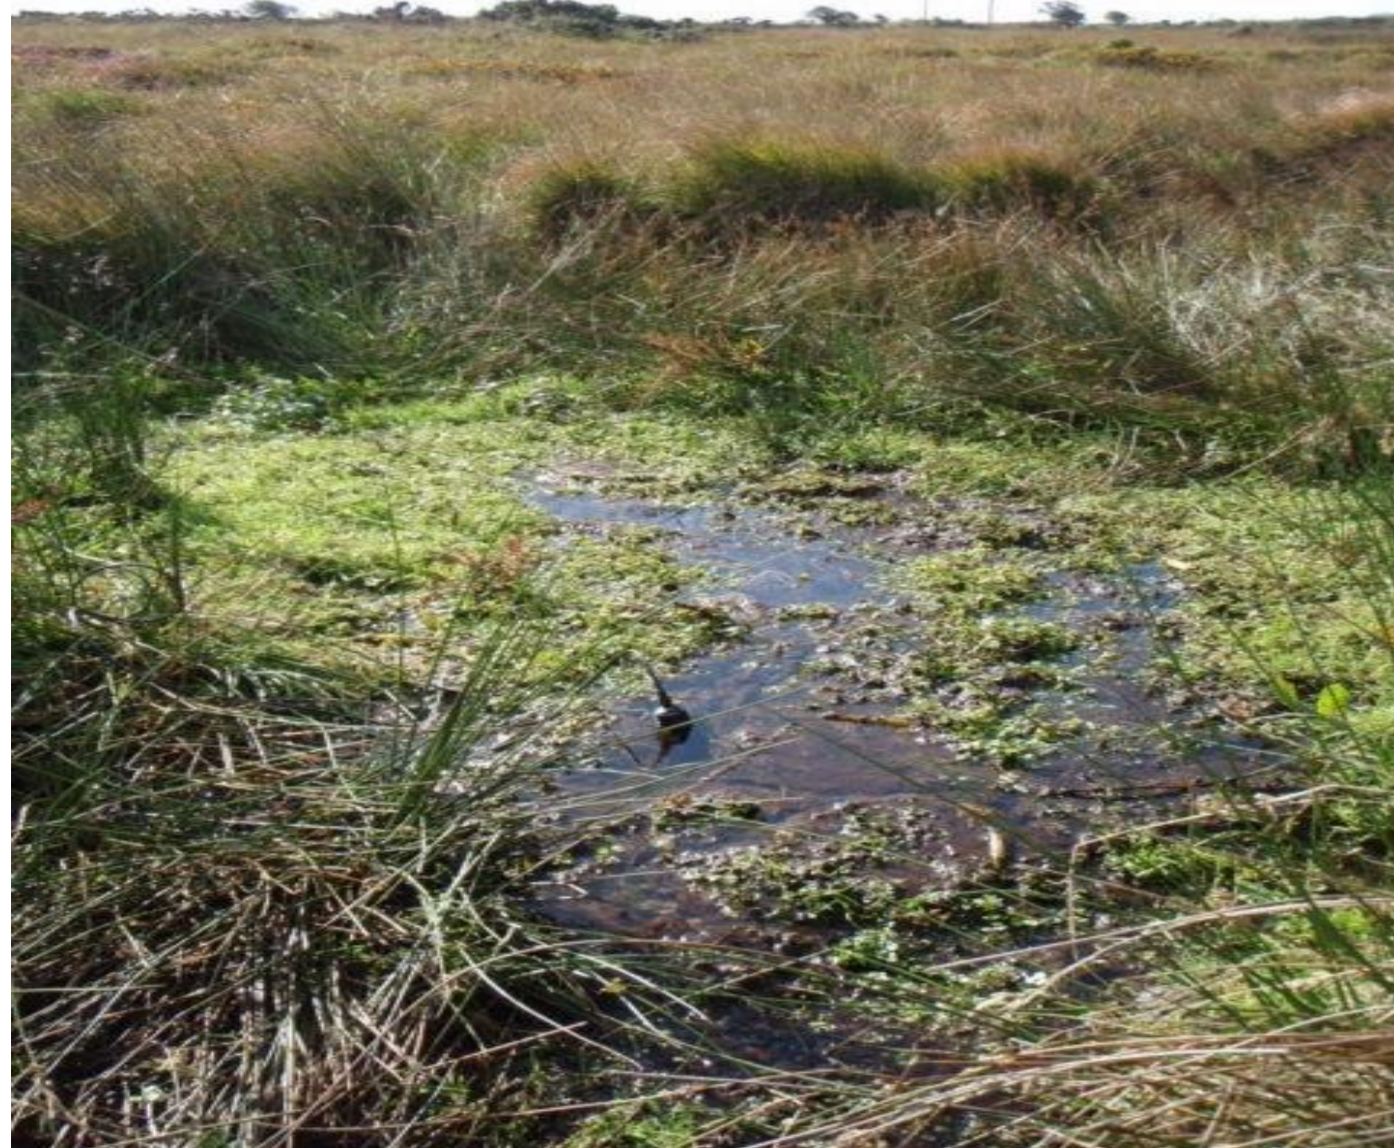
Above: pond in the west of the site receiving enriched water.

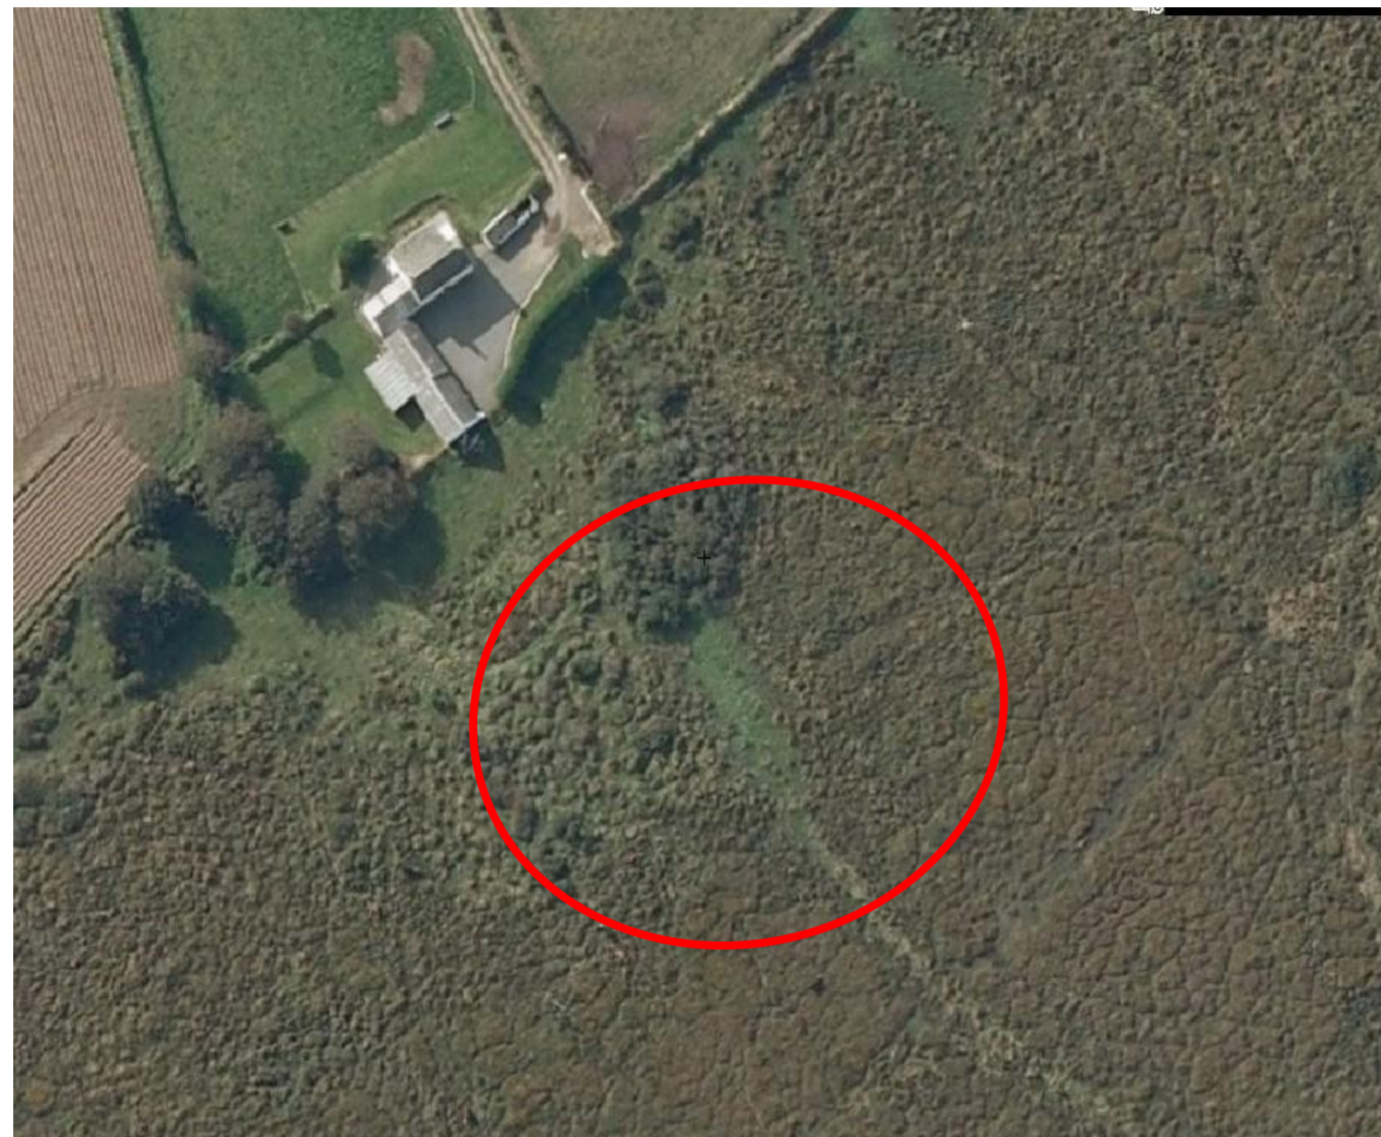
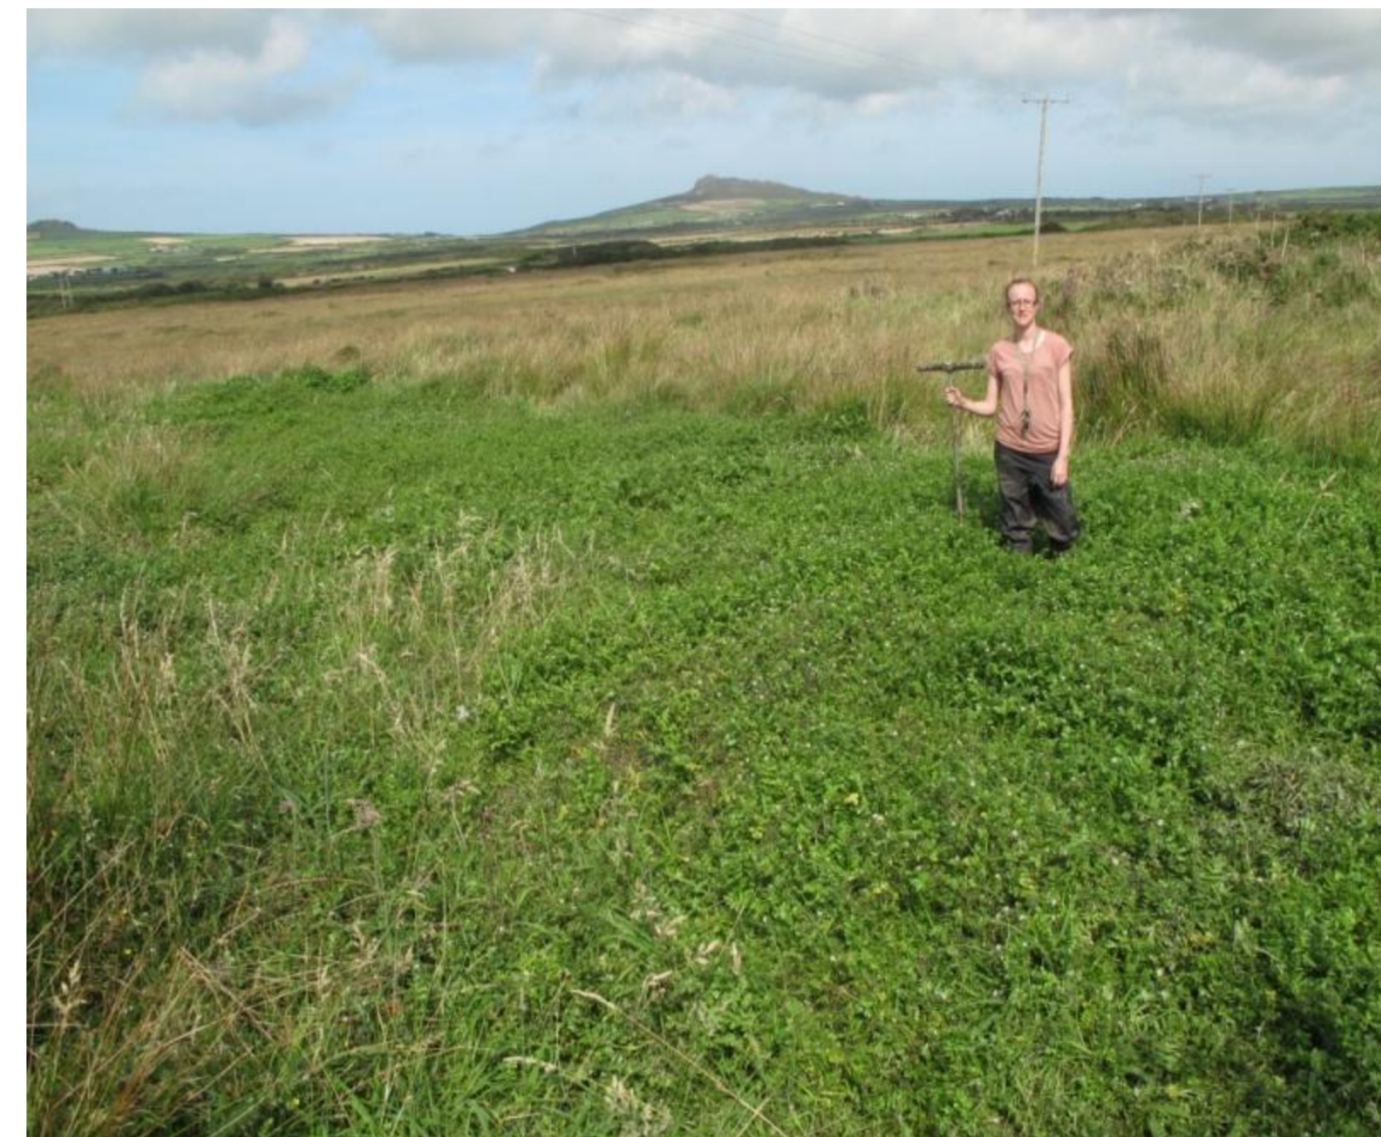
Above: Enriched vegetation from aerial photo (left) and on site (right)

A property to the south of Waun Fawr had a failing septic tank leaking into the site. This resulted in an enriched area clearly shown by the green flush in the aerial photograph (above right).

The septic tank has since been removed however there is still an area of enriched vegetation which requires further attention.

EAW determined the extent of the enriched vegetation by undertaking a hand auger survey. This survey provided a guide as to the volume of enriched material that may need to be removed. The underlying clay may help retain water and provide a protective layer to any bedrock groundwater. The excavation will aim not to remove substantial sections of this clay.

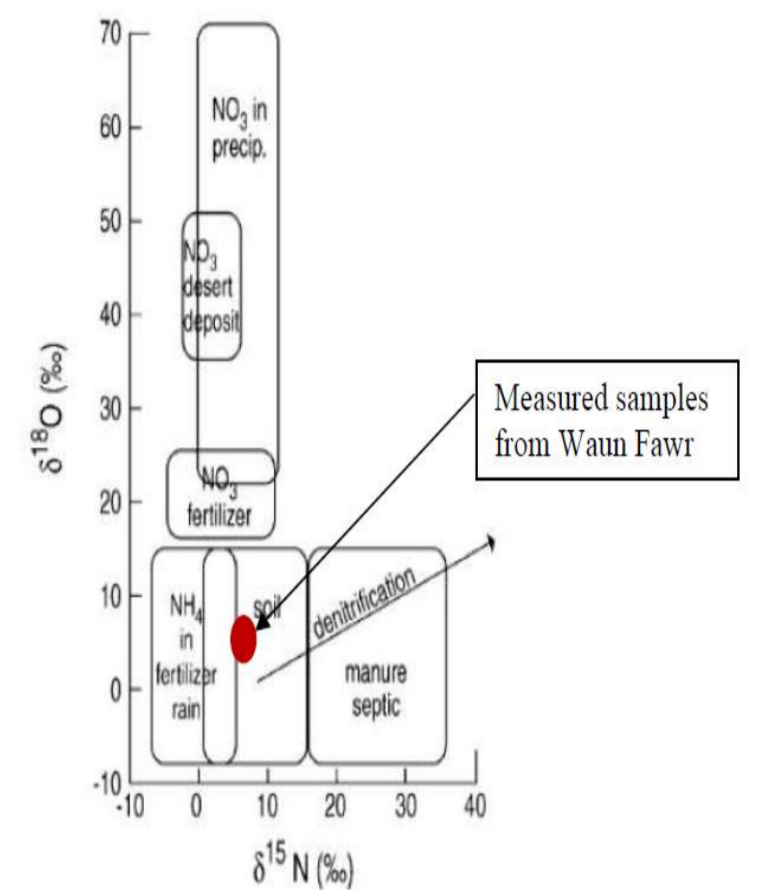
Right: Samples from Waun Fawr plot in the area shown by the red dot.

Analysis of Nitrogen and Oxygen isotopes can help determine the source of nitrogen. The analysis looked at nitrogen and oxygen isotopic composition of dissolved  $\text{NO}_3^-$  in water samples.

Results showed that the nitrogen is mainly derived from soil organic nitrogen originally from inorganic fertiliser inputs.

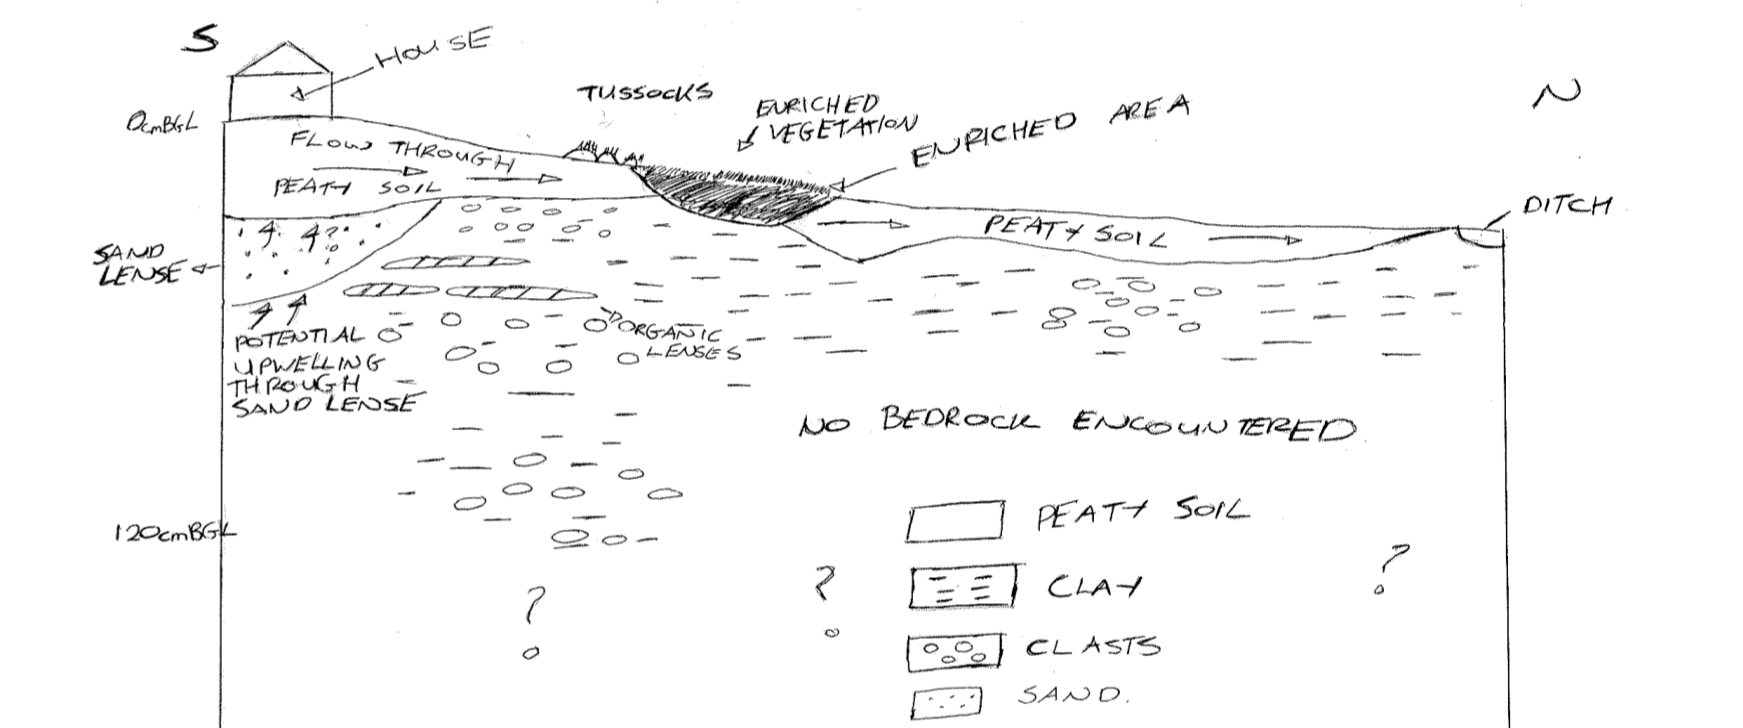
Above: initial conceptual model based on augers across the site
